# Environmental Study of Lac Mercier

Executive Summary of the Study  
(Phase 1 of the ALM Five-Year Plan 2021-2026)

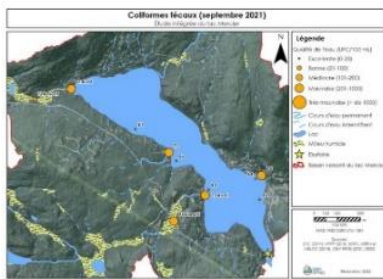
12 stations were sampled (Figure 25), with the objective of identifying the potential inputs of contaminants to the Lake, by measuring the concentrations of "phosphorus", "faecal coliforms" and to assess the "water quality" of the three tributaries of the lake (Figures 26, 27 and 27 and Appendix 3).

- **Attention** : Higher concentrations were observed in the Tributaries. High conductivity and slightly higher phosphorus concentrations at the outlet of the filtering marsh and exceedances of water quality criteria for certain sectors. Several exceedances were observed for faecal coliforms in some Tributaries but no exceedances in bays.

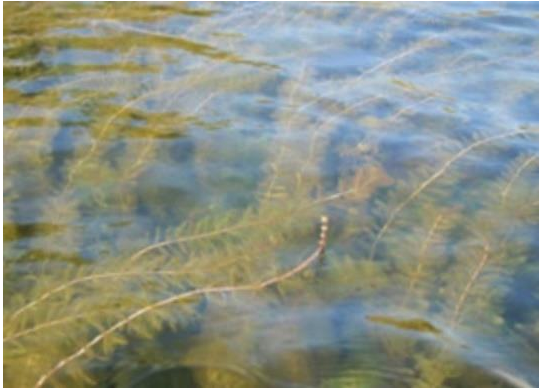
The EW is a perennial invasive exotic aquatic plant that can grow up to 6 meters and can be found up to 10 meters deep. Near the surface of the water, they branch and may continue to grow horizontally and produce emergent flower spikes. The EW then forms a dense canopy on the surface of the water.

The EW reproduces mainly by the fragmentation of its stems, which occurs naturally from mid-July until September. A small stem fragment can take root and form a new plant.

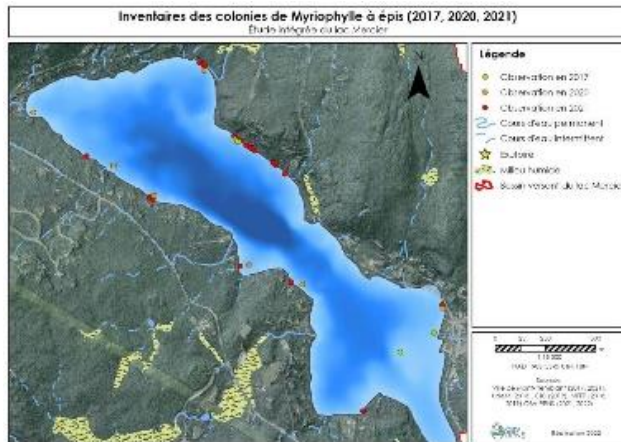
Figure 46 : Colonies de Myriophylle à épis (2017, 2020, 2021)

**Attention** : Presence of EW detected in 2003. In the summer of 2021, the City carried out a complete inventory of EW colonies (see Figures 45 and 46). The presence of new colonies of EW has been observed all around the lake and an increase since 2017 (Figure 15 and Art. 4.4).

The largest colonies of EW are located northeast of the lake. The colony considered the densest in the lake, listed in 2017 on the small island of rocks in front of the municipal beach, was not seen during the inventories of 2020 and 2021.

It is very unlikely that such a dense colony of EW disappears naturally over such a short period of time (Art. 4.6 and Figure 15). It is also likely that their cutting, trampling or removal may have caused the appearance of new shoots all around the lake.
